# The Efficacy of the Soil Conservation Technologies Used on the Slopes of Mount Rwenzori in Western Uganda

Nabalegwa Muhamud Wambede and Asaba Joyfred

Department of Geography and Social Studies, Kyambogo University Uganda  
Email: nabalegwaa@gmail.com; asabajoyfred@yahoo.com

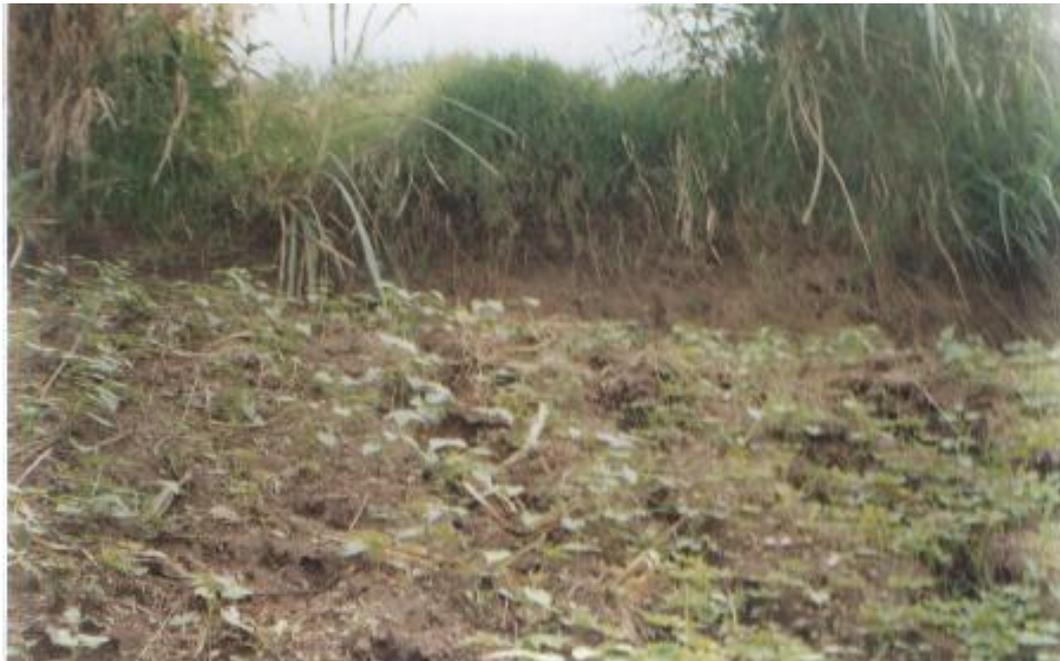
**Plate 1.** Severe rill erosion over a Beans farm plot caused by high velocity runoff flowing over the Steep lower terrace end on the Kibirizi middle slope.

The presence of poorly maintained terraces has indeed aggravated erosion problems on some Bugoye farm plots. Plate 1 above shows a poorly maintained modified bench terrace with over grown grass on a beans farm plot. As seen in the photograph, the lower terrace end has been over steepened by both cultivation and high velocity runoff and as such the steep slope created accelerates the speed of runoff increasing its erosive power leading to the development of large and deep rills and thus massive loss of soil and destruction of crops.

The results of this study generally revealed the fact that sizeable terraces can hardly be constructed and maintained on the steeper farm plots of Bugoye. As such conservationists should focus on combining terraces with other conservation techniques as cut off drains, diversion channels, mulching, soil cover crops, to ensure higher infiltration levels and a reduction in the amount of runoff, otherwise terraces alone will remain an inefficient method of controlling erosion.

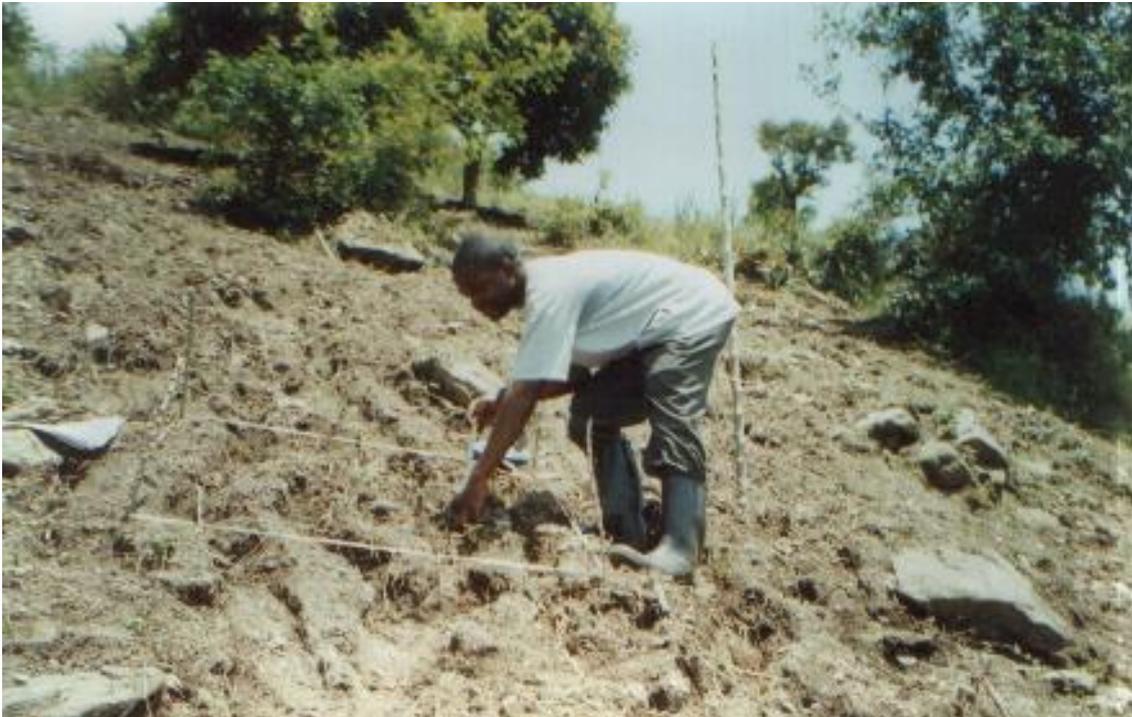
**Plate 2.** Measurements of the dimensions of the rills over a micro plot drawn on a freshly cultivated severely eroded cassava farm plot on the Muramba upper slope. The terrace is far below and was not captured.

Terraces especially those on the upper slopes were found to be a failed venture for the Bugoye farmers. Plate 2 shows the researcher measuring the rill dimensions to estimate erosion severity on a farm plot and as seen in the photograph high velocity runoff was found to have formed deep and wide rills on land portions in between terraces. As already noted, farmers in Bugoye were found to locate terraces at considerable distance away from one another. Such wide terrace spacing allows runoff to accumulate in

between the terraces thereby creating deep rills and destroying crops. In the photograph the rills formed by high velocity runoff were found to have swept the newly sowed seeds down slope causing a big loss to the farmer.

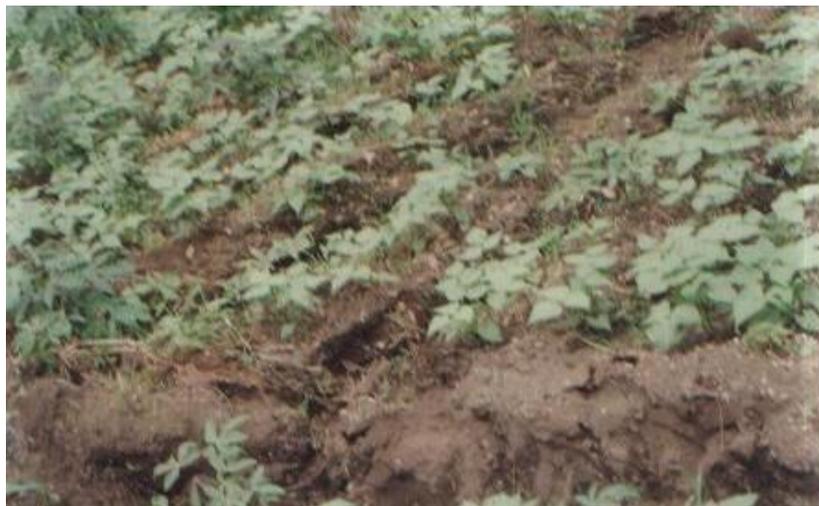
**Plate 3.** Severe erosion caused high velocity runoff flowing over submerged trash bund over a beans- cassava garden on the Nyakajoro middle slope. (One of the submerged bunds can be seen in the fore found)

Although trash bunds are meant to trap run-off and reduce erosion rates, old bunds were found to be a liability to soil conservation efforts. Plate 3 shows an old trash bund (*in the fore ground*) that has been submerged and over run by run-off. As seen in the photograph water running down slope in well-defined rills submerges and cuts through the already weakened trash bund causing even more severe erosion. This is evidence that trash bunds are unsuitable for controlling erosion over steep slope where water velocities are high. As such where their use is inevitable trash bunds should not be used in isolation.

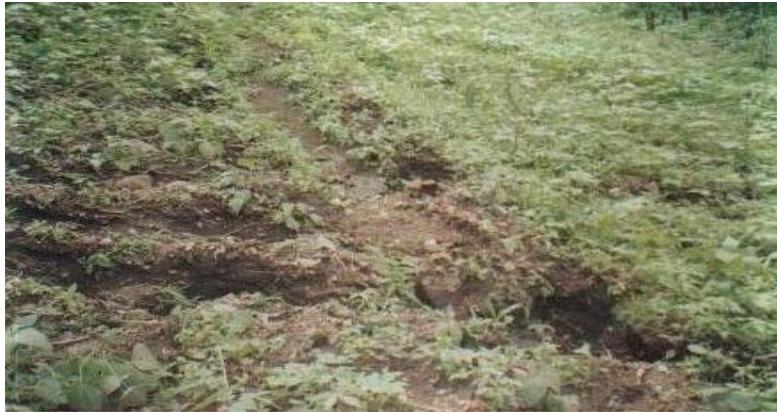
**Plate 4.** An over silted water diversion channel initiating severe rill erosion down slope in a Beans-garden on the Kyikubangali lower slope.

Water diversion channels in Bugoye were indeed found to betray the very purpose for which they are meant. Plate 4 above shows a shallow highly silted diversion channel in a beans garden. As seen in the photograph, run-off from upslope has broken through the diversion channel there by creating large and deep rills leading to massive loss of soil and destruction of crops. In fact the crops that were in the areas now occupied by the rills have been washed down slope. Unless the designs of these channels are improved, the structures will remain a liability to the farmers.

Since only well designed and maintained channels are capable of controlling erosion effectively, the poor maintenance and therefore shallow depths of the diversion channels in Bugoye have limited their ability to hold water from intensive storms and as such the water diversion channels over the Bugoye upland farms were found to be inappropriate to the local farm conditions and inefficient in controlling erosion.

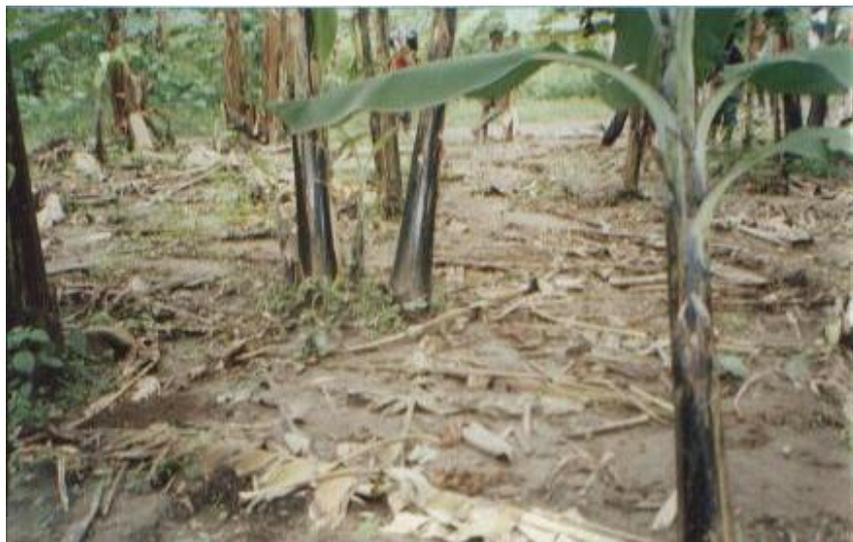
**Plate 5.** Sheet erosion caused by run-off sweeping mulches over a thinly mulched Banana farm plot on the Bulindiguru lower slope.

improvement in Bugoye. Plate 5 above shows a thinly mulched Banana garden where most of the mulches have been washed down slope by accumulated run-off released from farm plots upslope. The application of mulches in isolation without physical conservation structures exposes mulches to great volumes of run-off and as such the thin mulches are easily swept away causing severe rill erosion that exposes the banana roots, weakens the banana plants, making them susceptible to falling, a problem that needs attention.
